Problem Report

Report Number: 5

Project Name: TeraPixel APS for CALICE **v1.1**

Item: Configuration Registers: Power droop in buffer supplies

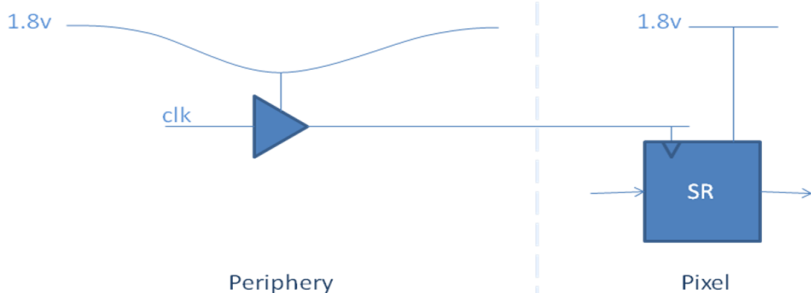
Problem
<ul style="list-style-type: none"> • Were reporting many errors and not holding the correct data • Problem due to different power domains and high loading of “slow” clock drivers

<p>The diagram illustrates a clock signal path between two power domains. On the left, labeled 'Periphery', a blue triangle represents a clock buffer. It is connected to a 1.8v power supply. A signal line labeled 'clk' originates from the buffer. On the right, labeled 'Pixel', a blue square represents a Shift Register (SR). It is also connected to a 1.8v power supply. A vertical dashed line separates the 'Periphery' and 'Pixel' domains. The 'clk' signal line crosses this boundary to connect to the SR register.</p>
<p>Originator (Sign/Date)</p> <p>JC</p> <p>Project Manager (Sign/Date)</p>
Remedial Action
<ul style="list-style-type: none"> • Fixed by driving one of the power domains at 1.6v (previously 1.8v) • Implemented using the power module developed for TPAC1.0 with updated resistor values and driving VDD1V8sram through J7 • Proved, reliable fix provided 2% tolerance on resistors on power module board.
