# TPAC1.2

JC / 1<sup>st</sup> July 2009

Results from Barnaby Levin (summer student)

# Config load errors

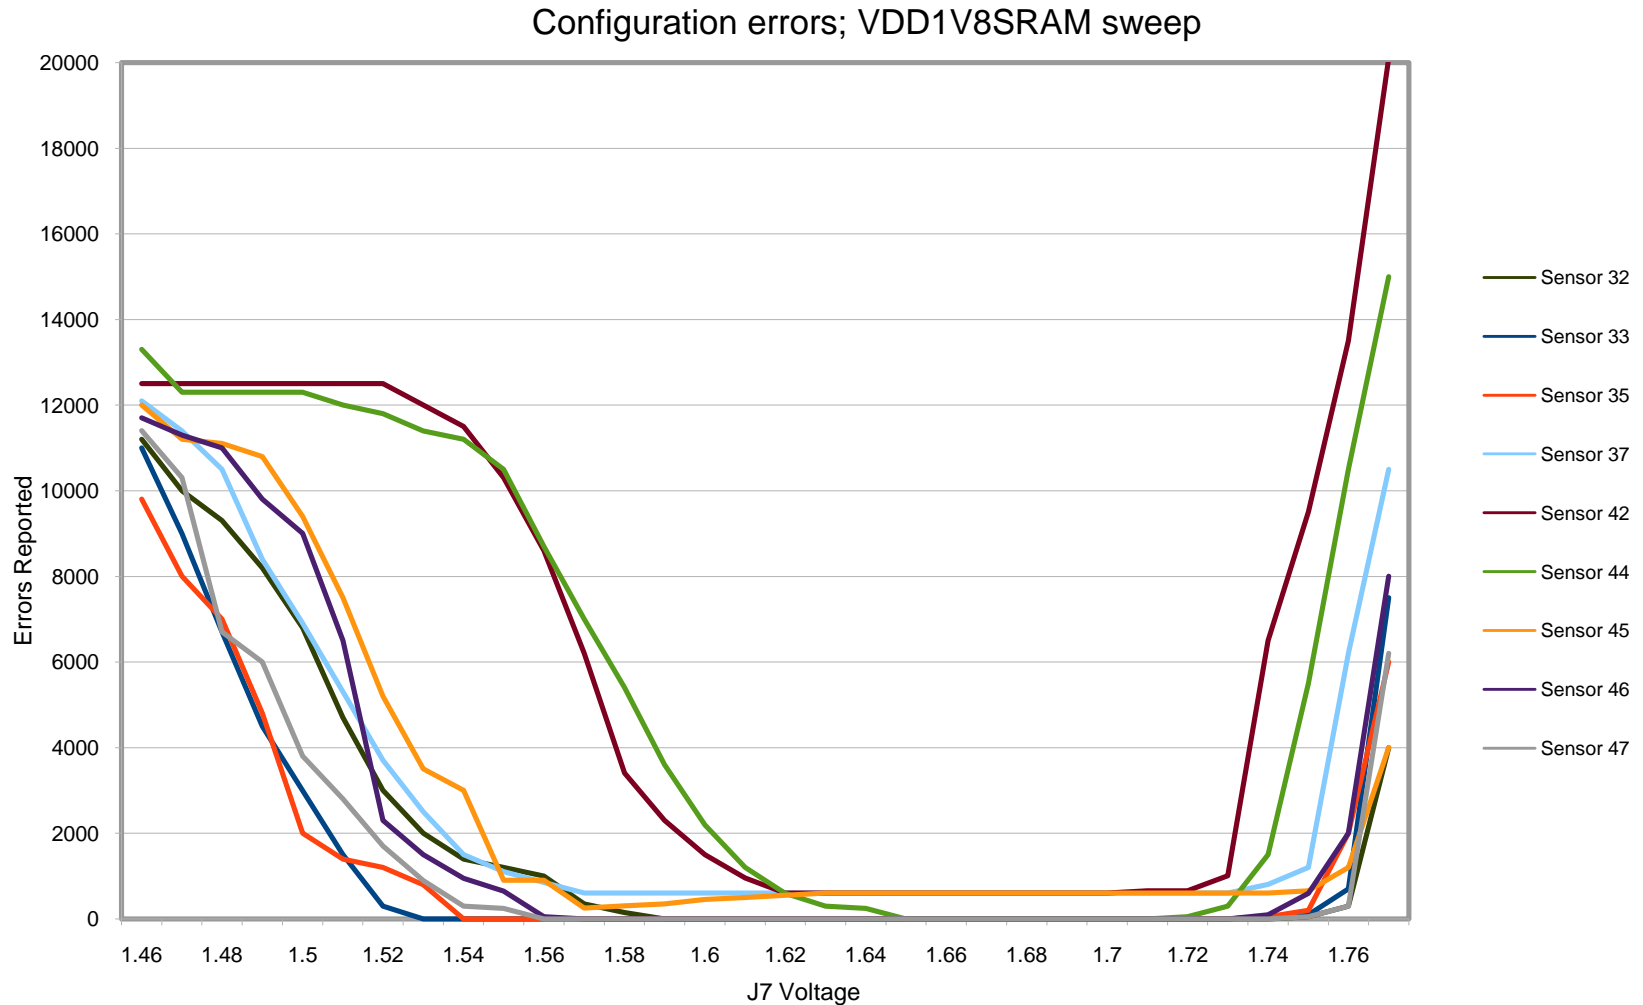
- Vary VDD1V8SRAM, plot configuration errors (random data)

- Single-column defects are generally “real” ie cannot be fixed by adjusting VDD1V8SRAM
- Nominal voltage 1.62v ( $\pm 2\%$ ) as previously set up is generally good
- Two sensors tested are “on the edge” at 1.62v and showed variable/increasing dead columns during trimming
  - A special version of the power dongle set to 1.68v ( $\pm 2\%$ ) has been made for these boards
  - No correlation between these chips and wafer
- Similar study at different temperatures will be conducted soon
