TPAC1.2 Results

Jamie Crooks

1st June 2009

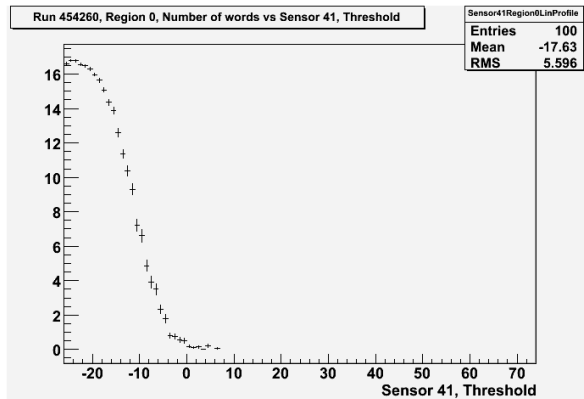
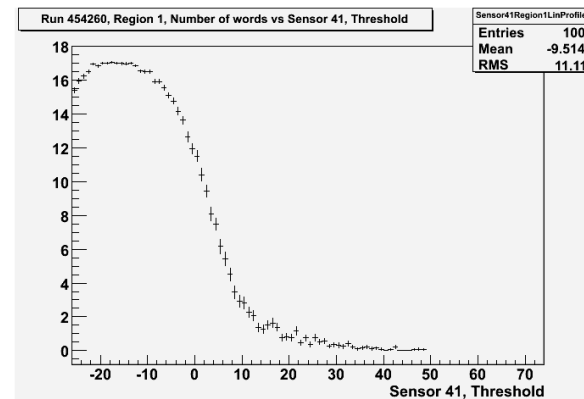
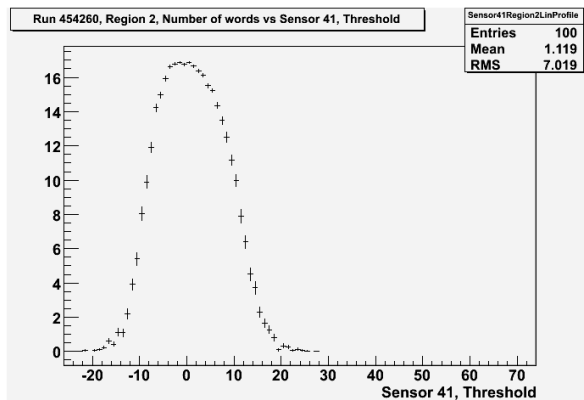
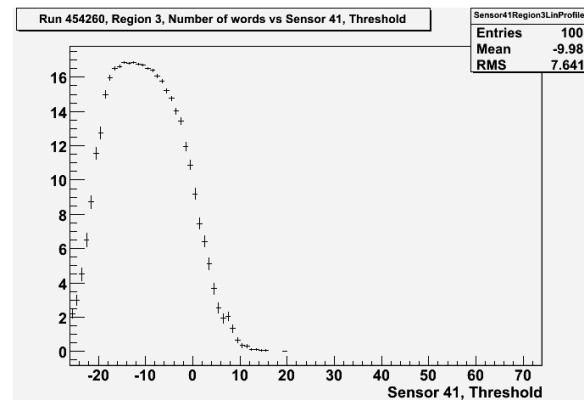
Per-Pixel threshold scans (noise)

- Randomly selected single pixel in each region
- Noise is **Gaussian** 😊
 - Pixel shielding added on metal 2 appears to help
 - Coupling/oscillation at low thresholds is not evident

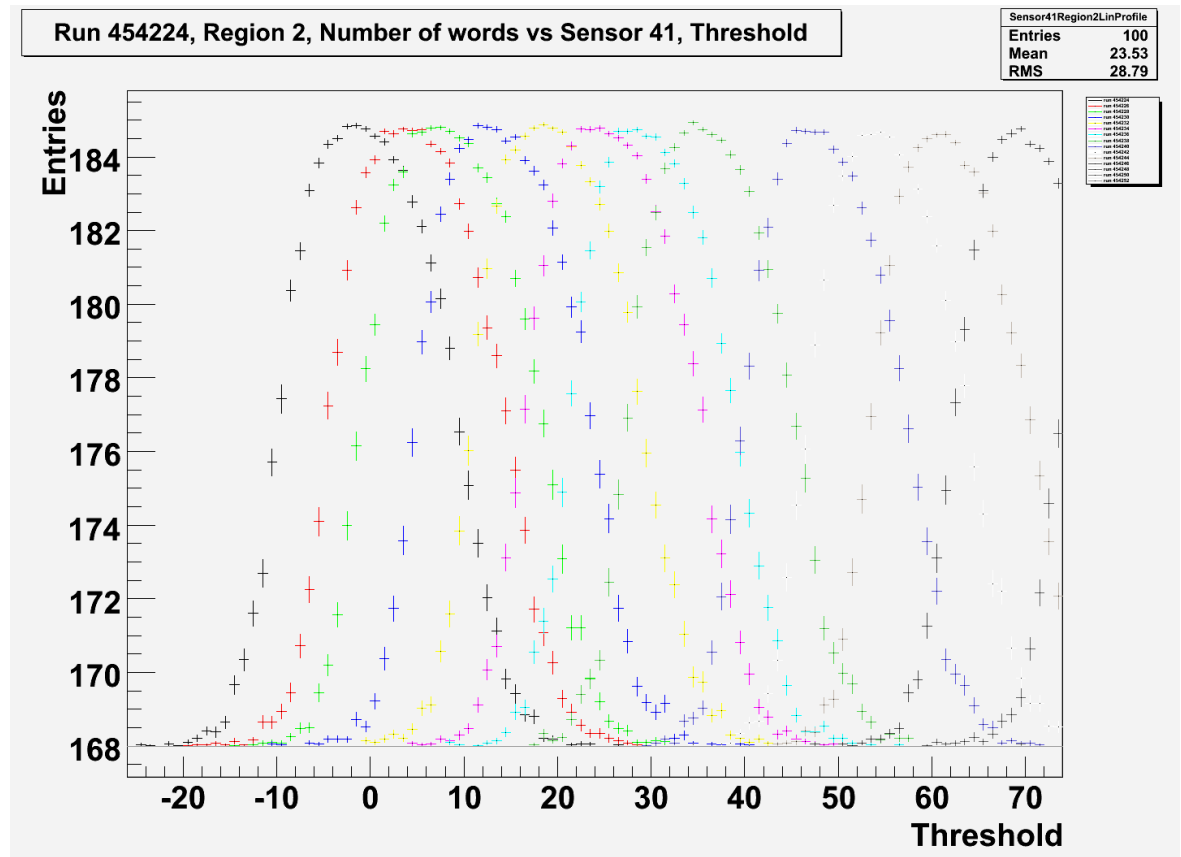
Single pixel trim scan

- Trims 0,2,4,6,8,10,12,14,16,18,20,22,24...

- The trim range still needs to be set up correctly
- Was never done for TPAC1.1 which had the larger #bits
- May involve a resistor value change
- Once per-pixel spread is known I can set this
- Sooner the better (for modifying PCBs)
- Currently the range should be twice that on TPAC1.0 with 4x resolution

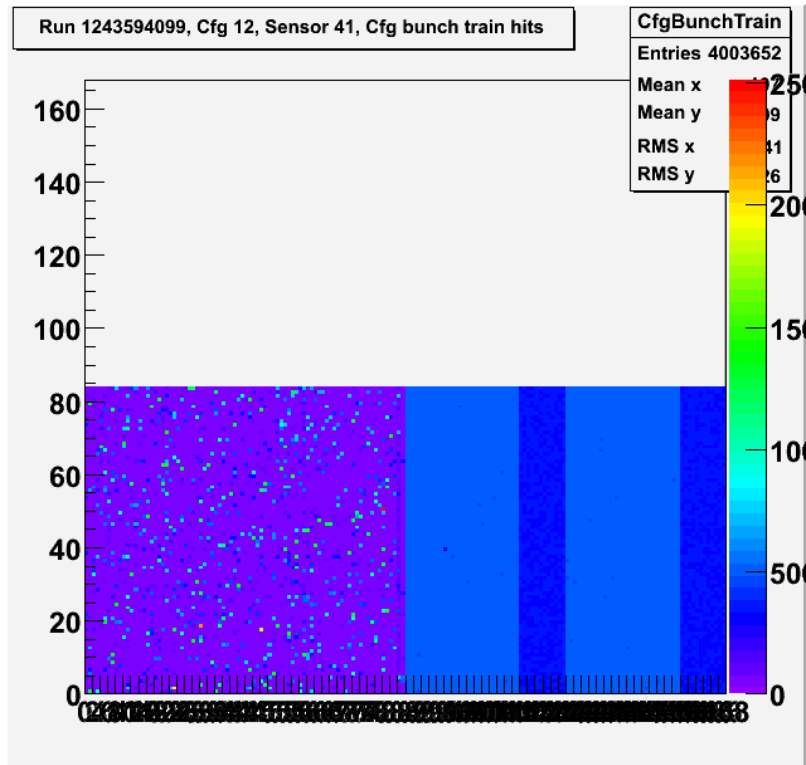
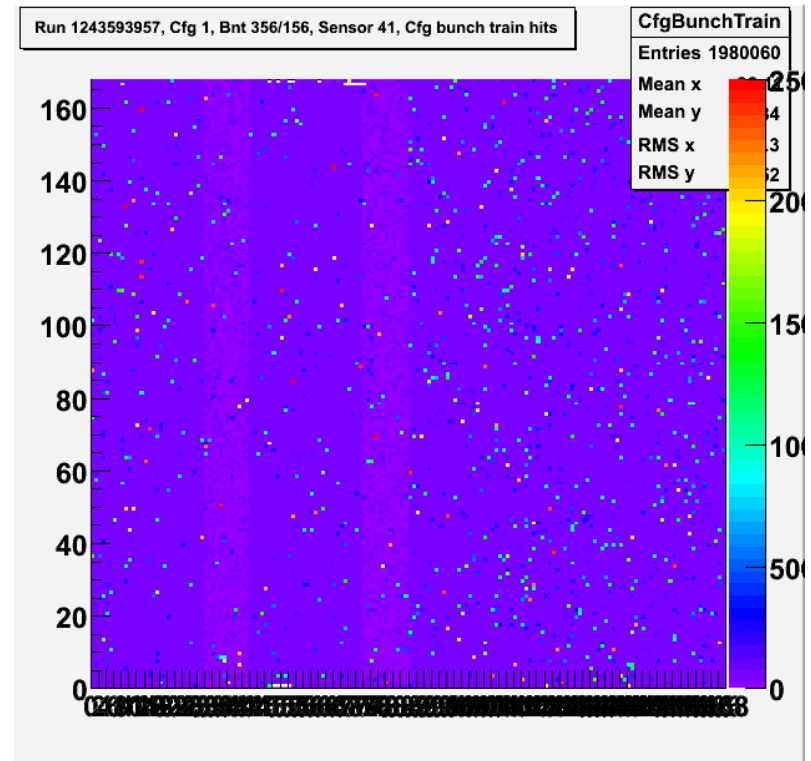
Pixel addresses (noise)

- TPAC1.1
 - Addressing bug

- TPAC1.2
 - Full addresses restored
