TPAC1.0

Jamie Crooks

TPAC1.1 Status

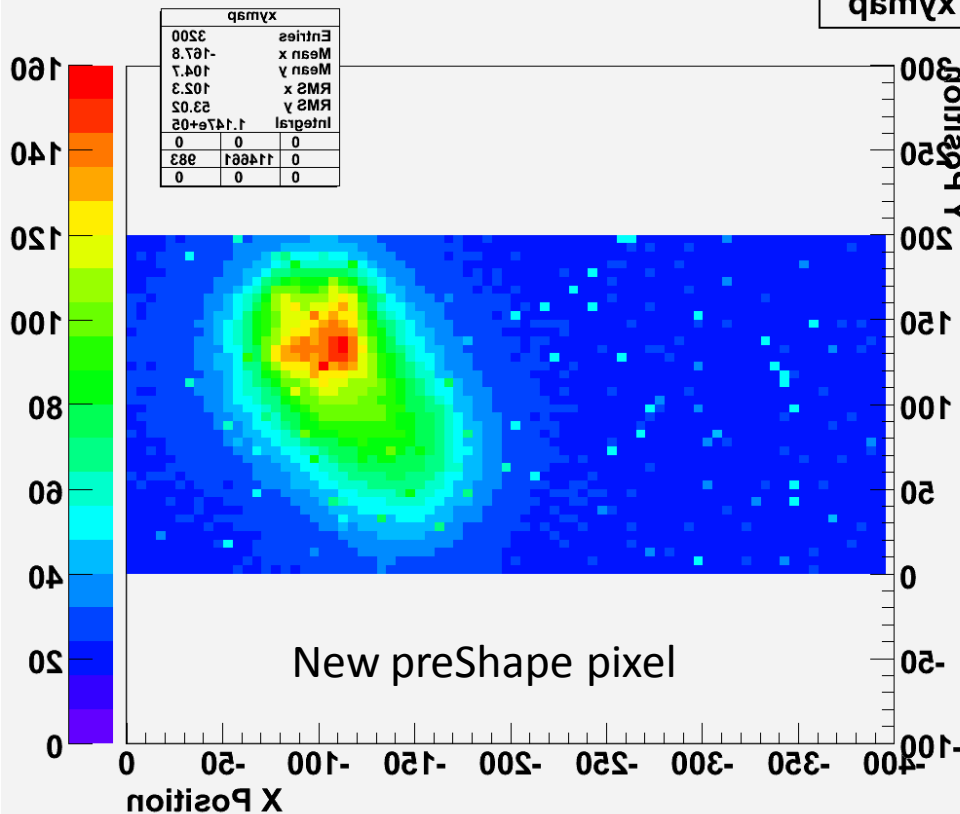
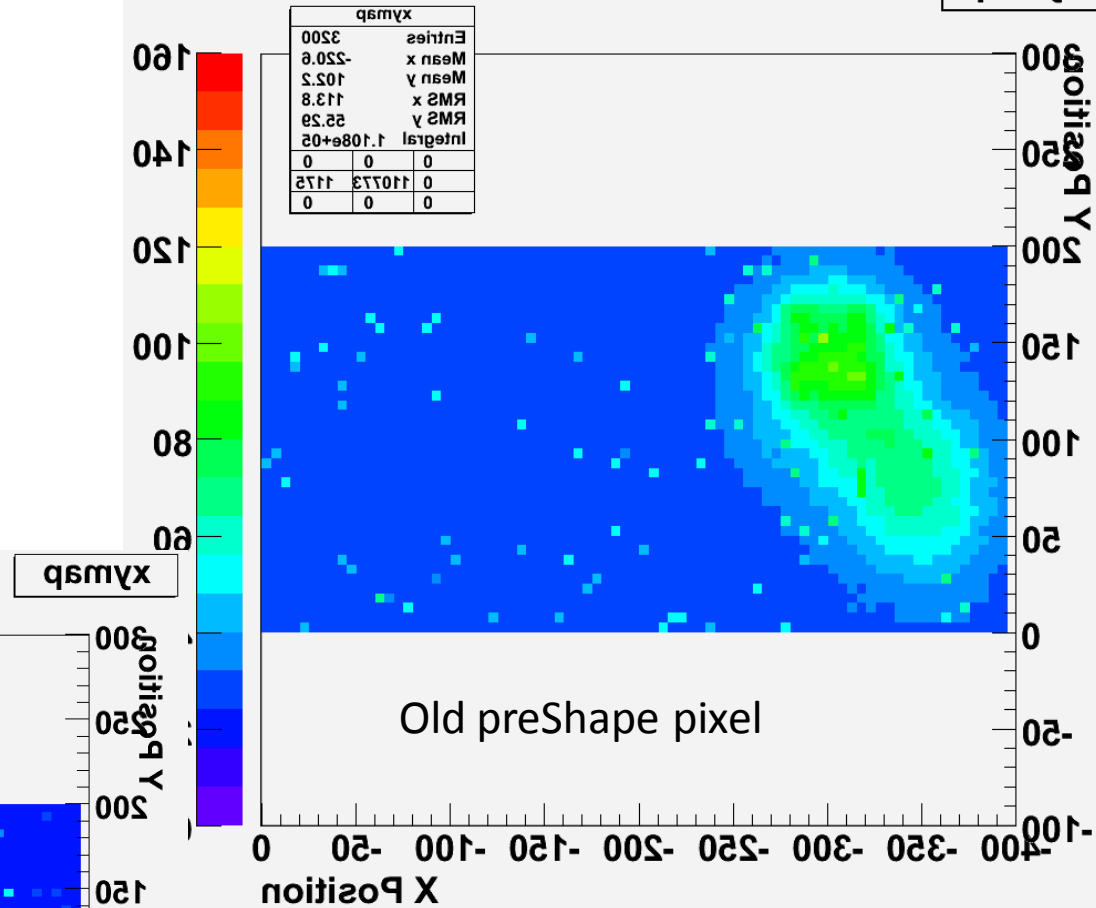
Laser Scans

First look!

5um spot
5um steps
Analog readout
Mean Signal
(20 samples)

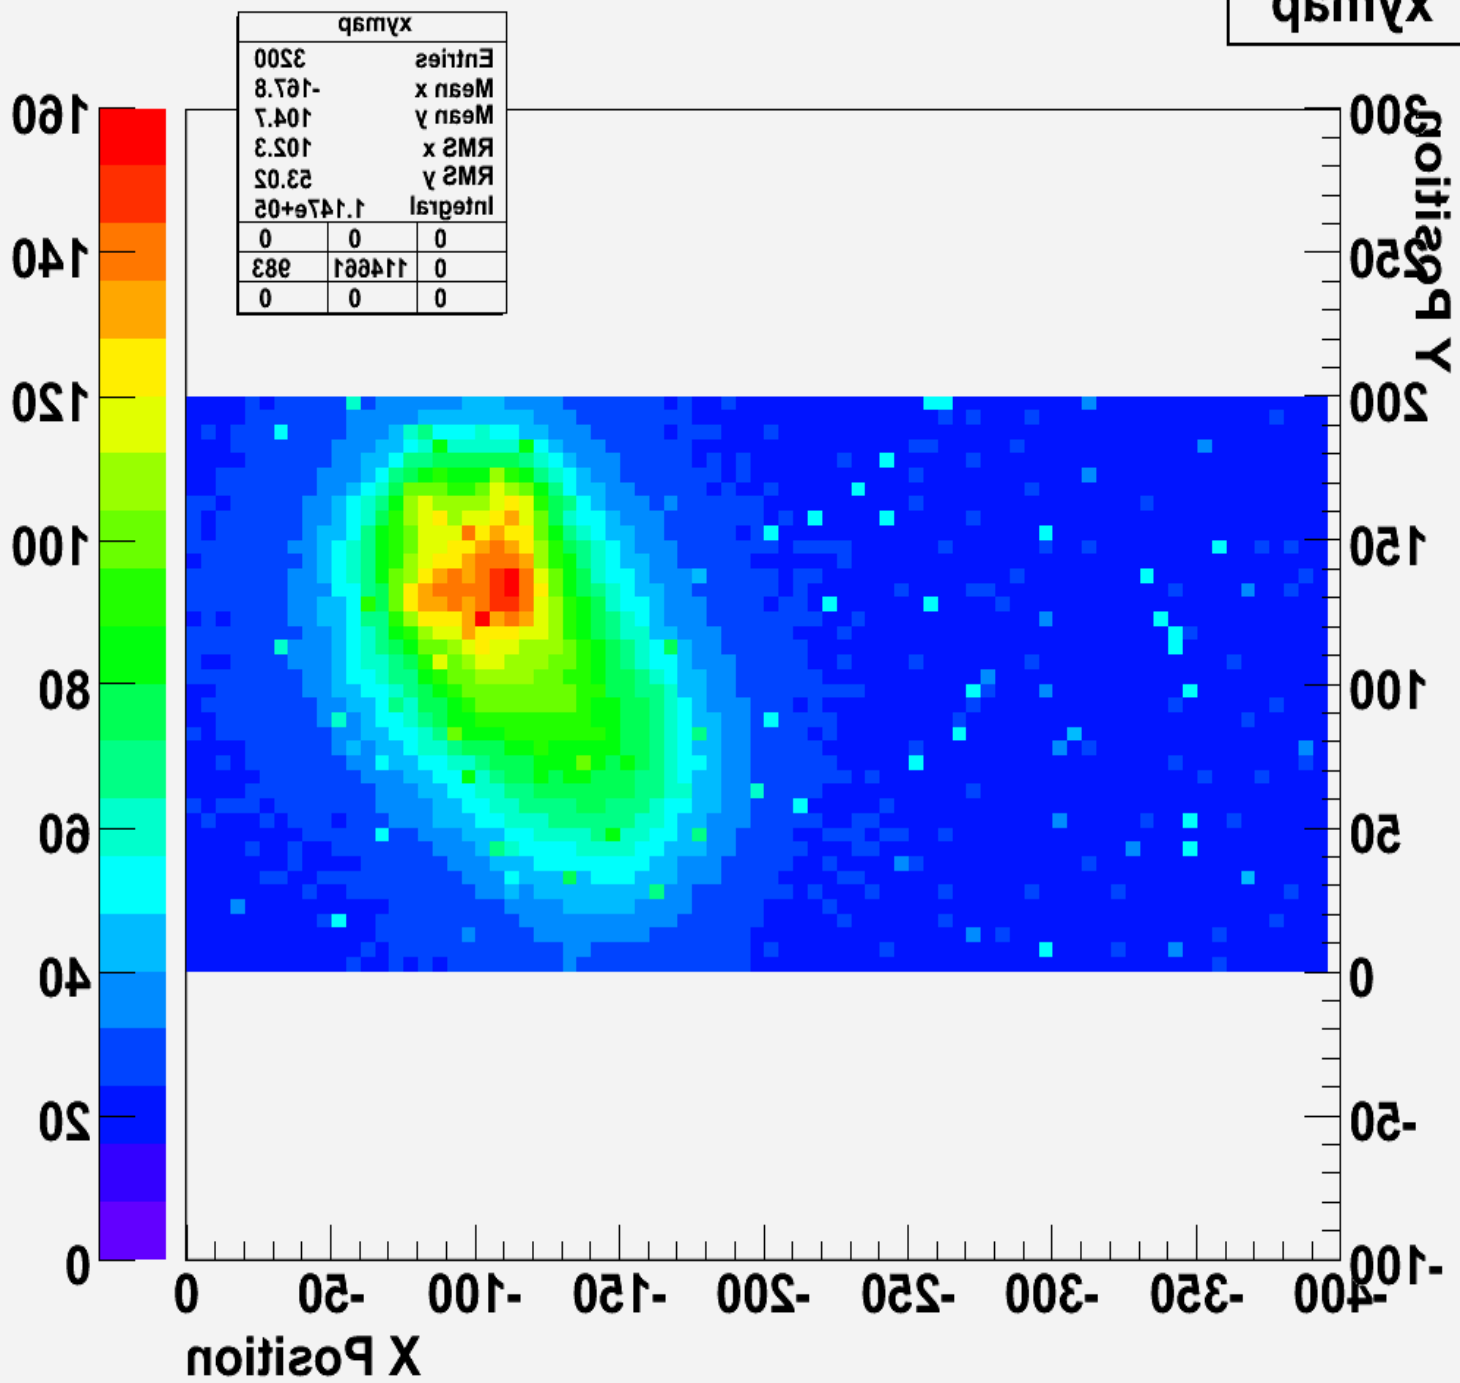
qxymap

Laser
Scans

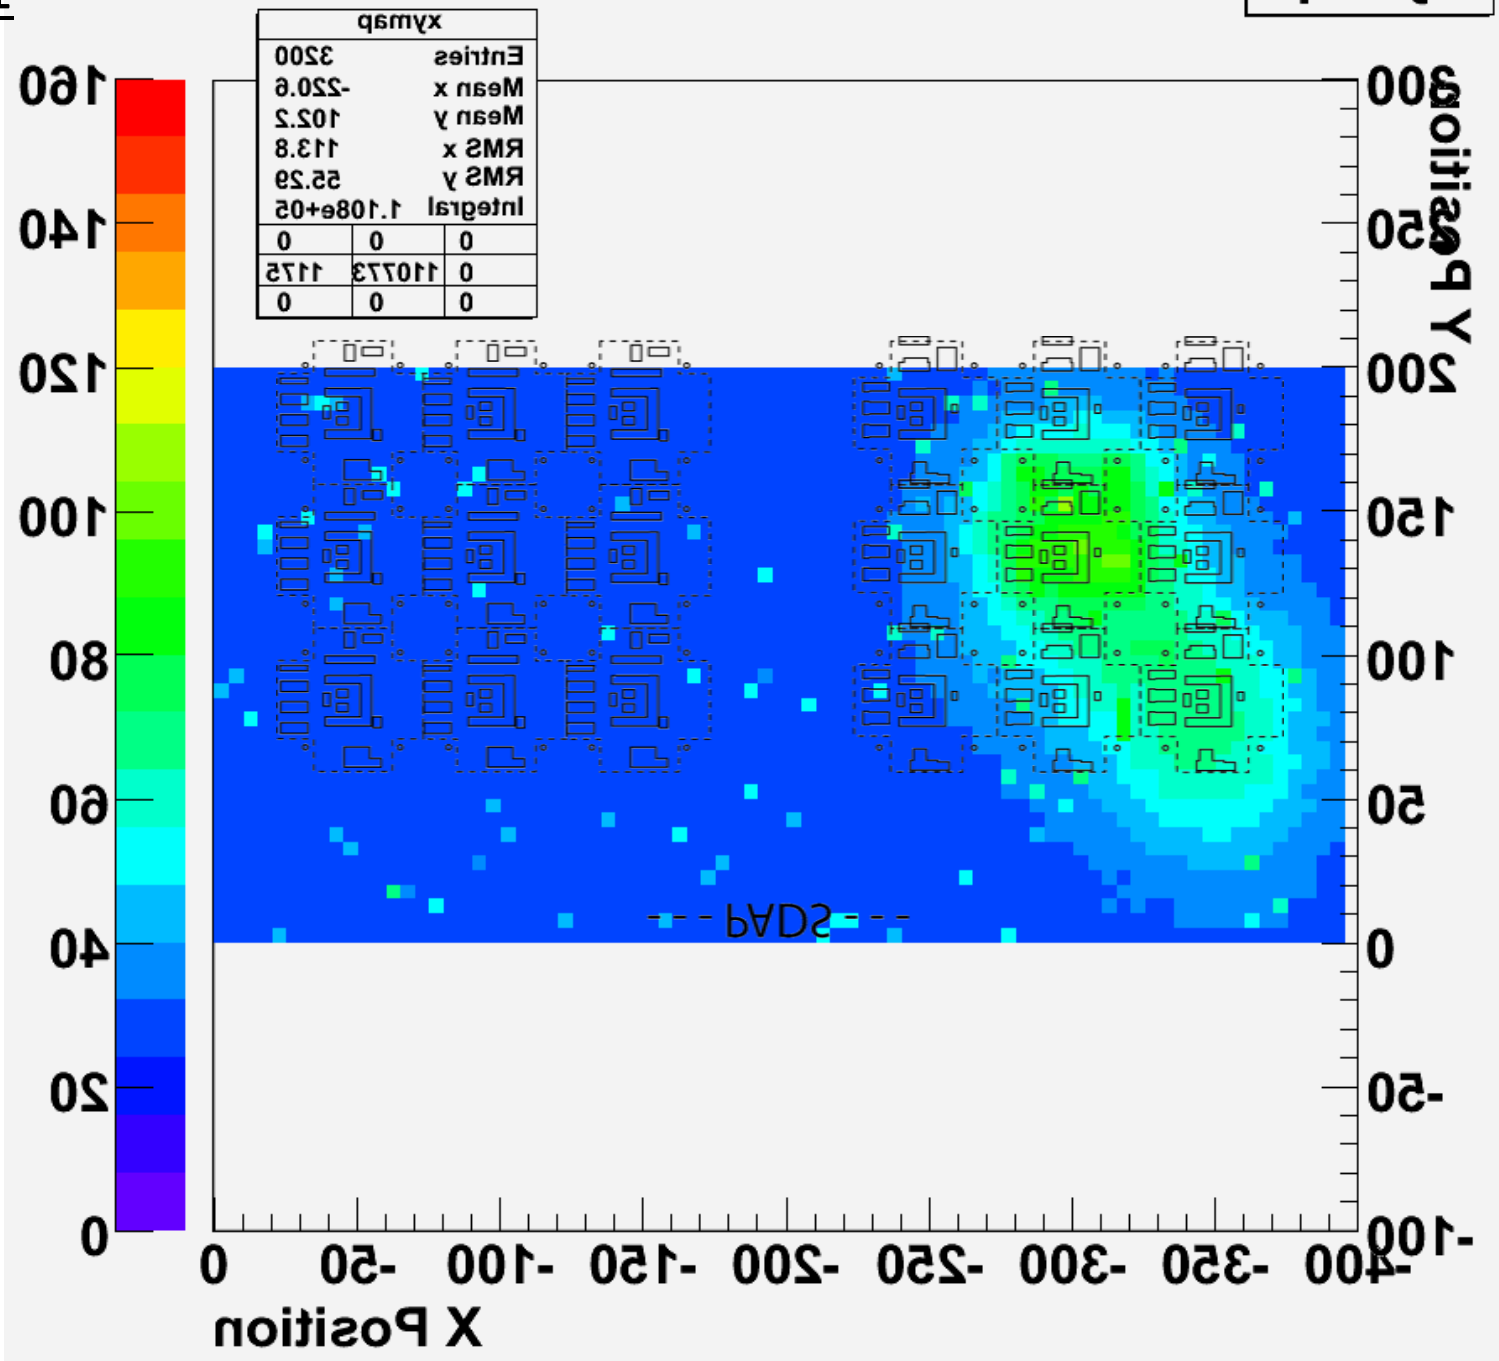
qsmxp

Laser
Scans

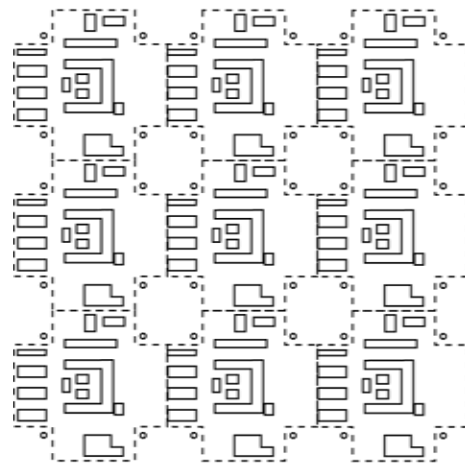
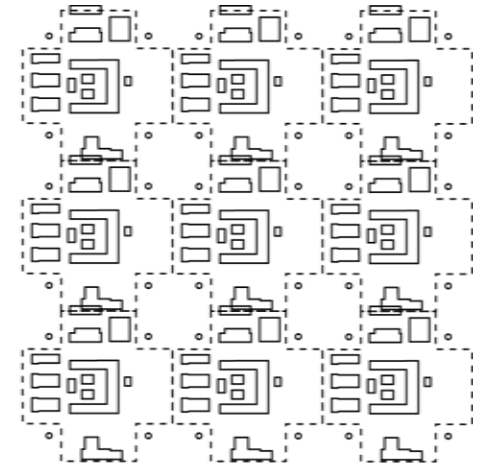
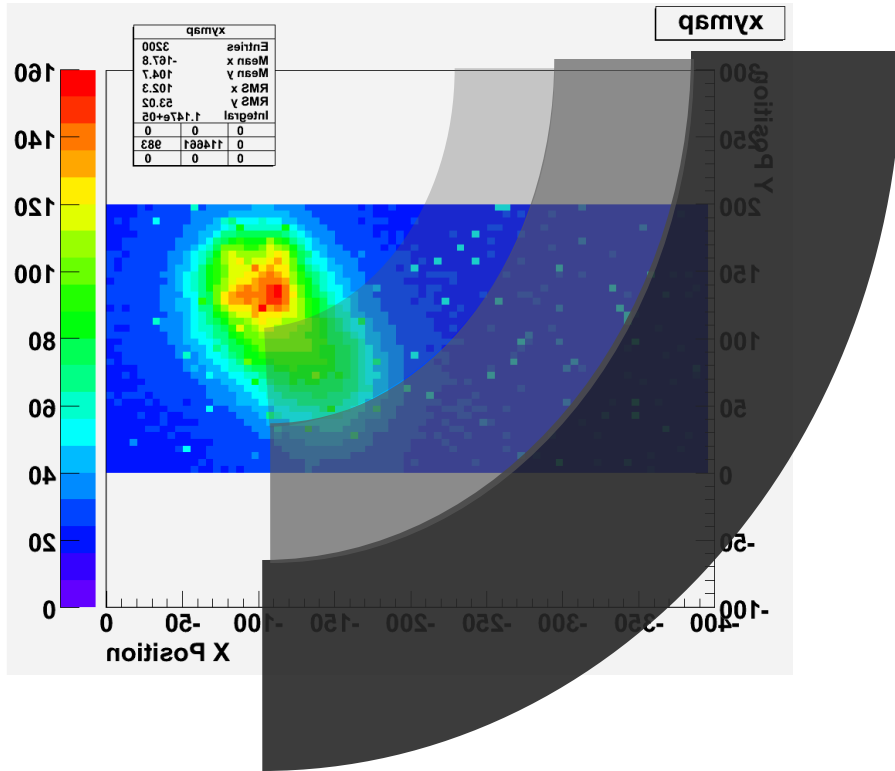
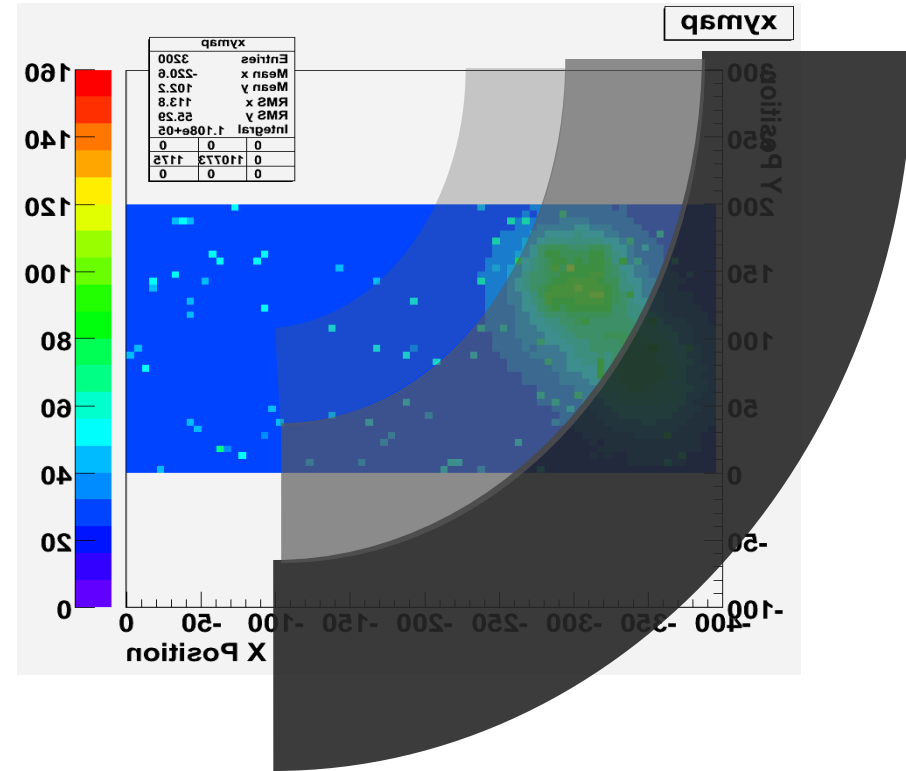
Explanation?

- PCB hole seen to be misaligned (camera on laser microscope used to check known positions of pixels)
- Next: Try another sensor!
